News from SubTerra, Inc.®

## *Differing Site Condition Evaluation Pipe Jacking Using a 51-in Ackerman Open Spoke TBM*

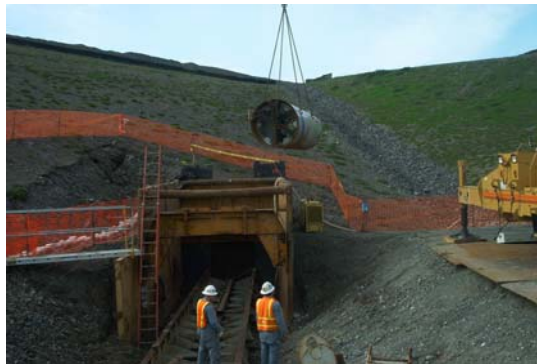
However, significantly more boulders were encountered both individually and nested with other boulders and cobbles resulting in impacts to TBM operation and significant delays. Impacts included, but were not limited to:

1. Excessive wear and tear on the cutterhead, TBM, jacking system, and backup systems.
2. Steering problems leading to pipe binding, increased skin friction, and excessive jacking pressures.

3. The need to install intermediate jacking stations as intermediate solutions to increased skin friction and increased jacking pressures.
4. Extremely slow progress associated with consistently encountering ground with nested cobbles and boulders.

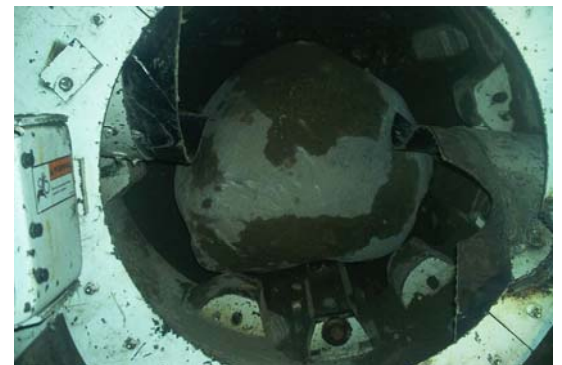
1. Removing numerous boulders.
2. Digging out a greater than 4-ft diameter boulder.

3. Re-setting the pipe back to line and grade after removal of the greater than 4-ft diameter boulder.
4. Drilling and hydraulic splitting another boulder that could not be removed whole through the cutterhead.
5. Cutterhead repairs and pick replacements.
6. Installing Intermediate Jacking Stations.
